TEA FIRE SEWER STUBS

January 2009

TEA FIRE LATERAL
ABANDONMENT PROJECT

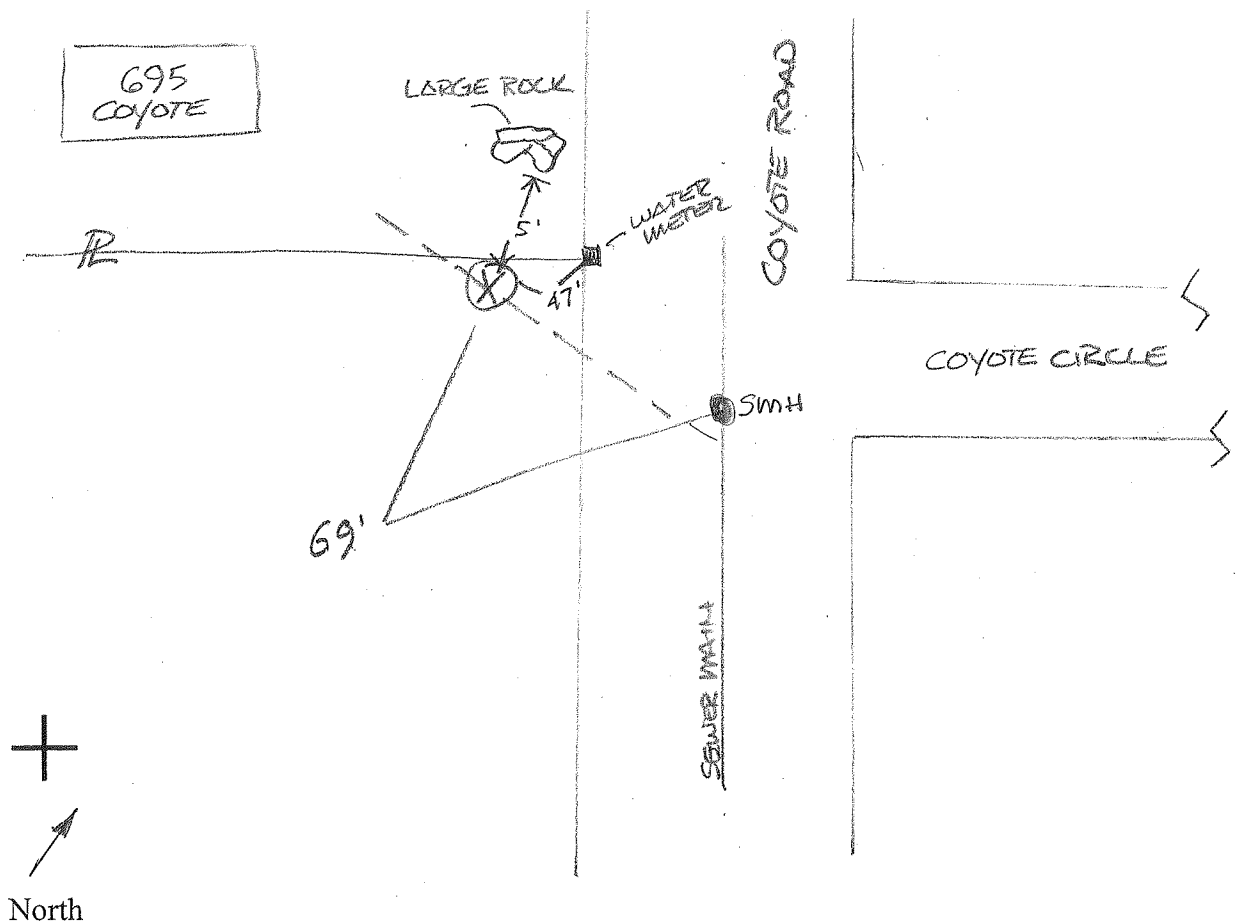
- Date: 1-9-09
- Property Address: 695 COYOTE RD.
- Location/Address of actual excavation (also see diagram attached):
- Size & material type of sewer main: N/A
- Size & material type of lateral: 4" PVC
- Depth of Wye connection: 27"
- Distance of lateral from centerline of downstream manhole: N/A
- Excavation dimensions: 2 x 2
- Brief description of the site (utility conflict/traffic/soil type/other issues):

X = CAP

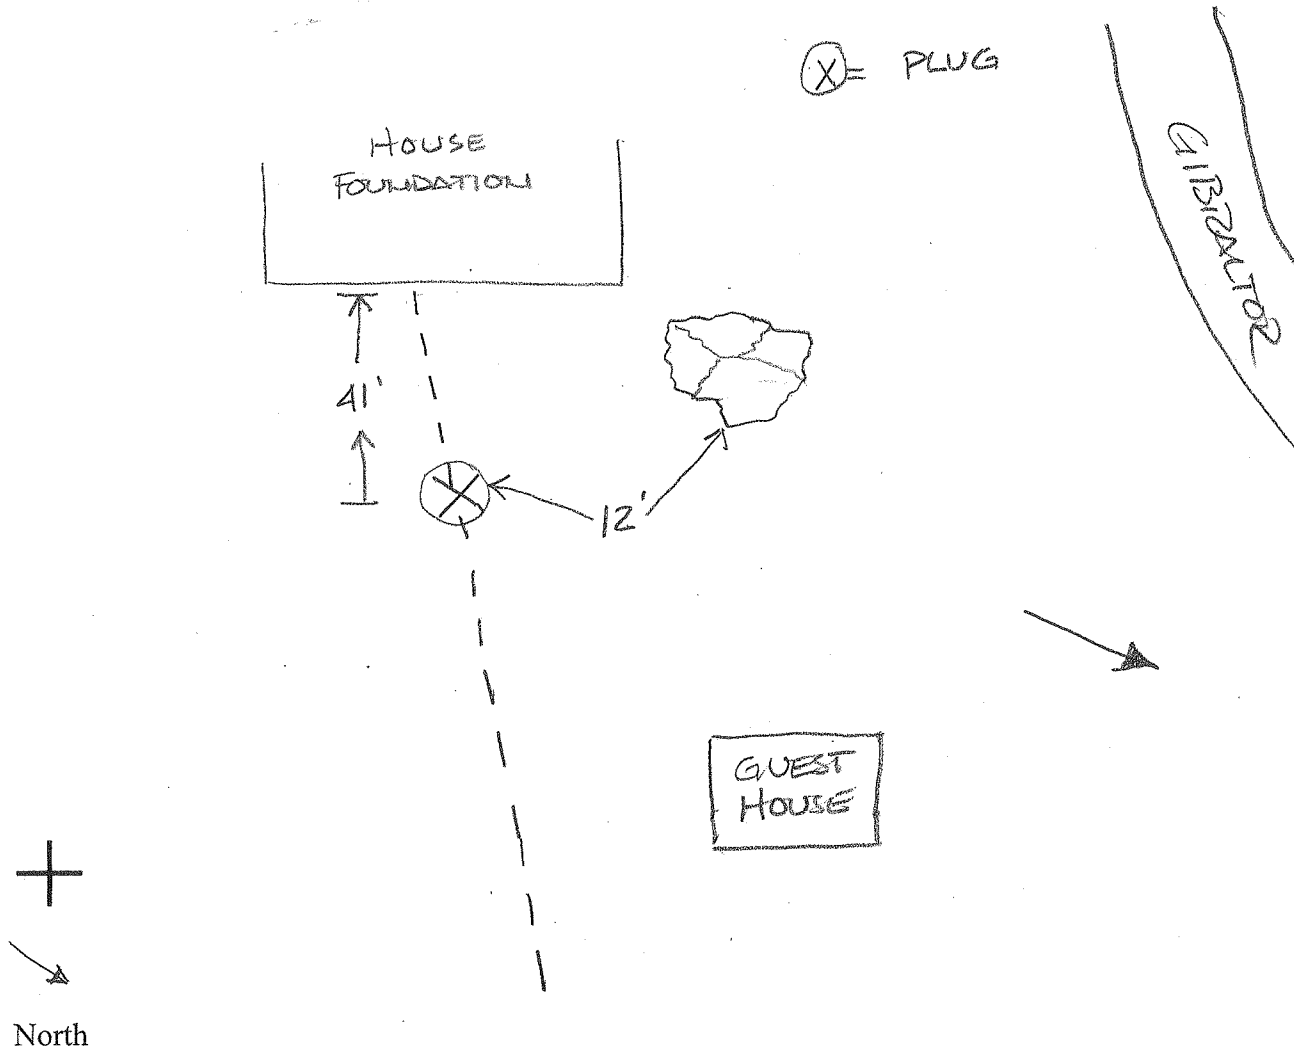
- Date: 1-9-09
- Property Address: 1944 GIBRALTOR
- Location/Address of actual excavation (also see diagram attached): SEE BELOW
- Size & material type of sewer main:
- Size & material type of lateral:
- Depth of Wye connection:
- Distance of lateral from centerline of downstream manhole:
- Excavation dimensions:
- Brief description of the site (utility conflict/traffic/soil type/other issues):

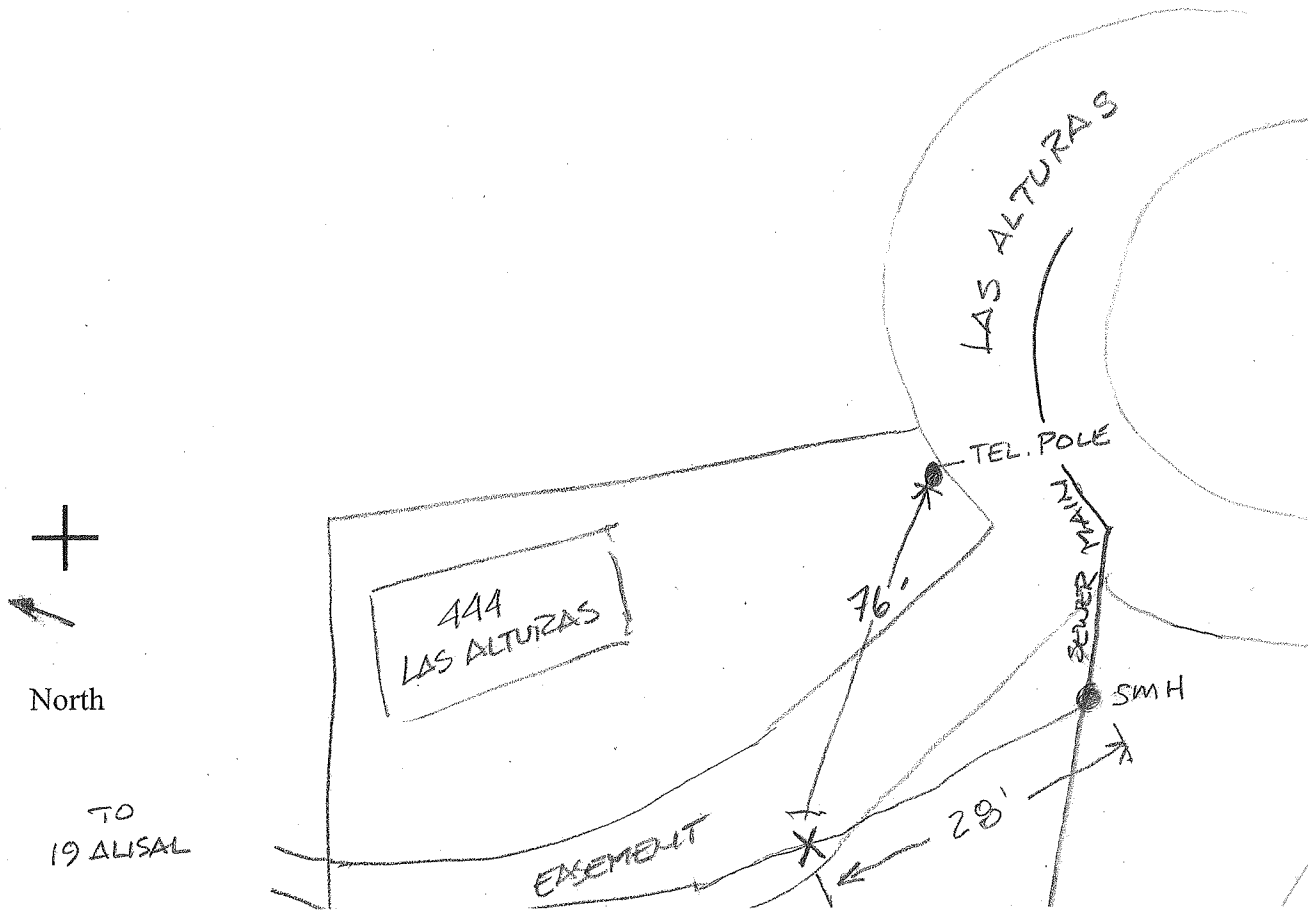
- Date: 1-8-09
- Property Address: 144 LAS ALTURAS
- Location/Address of actual excavation (also see diagram attached):
- Size & material type of sewer main: N/A
- Size & material type of lateral: 4" ABS
- Depth of ^{CAP}Wye connection: 24"
- Distance of lateral from centerline of downstream manhole:
- Excavation dimensions: 3x2
- Brief description of the site (utility conflict/traffic/soil type/other issues): 2 LATERALS IN 1 TRENCH, ONE SERVING 19 ALISA

X = PLUG

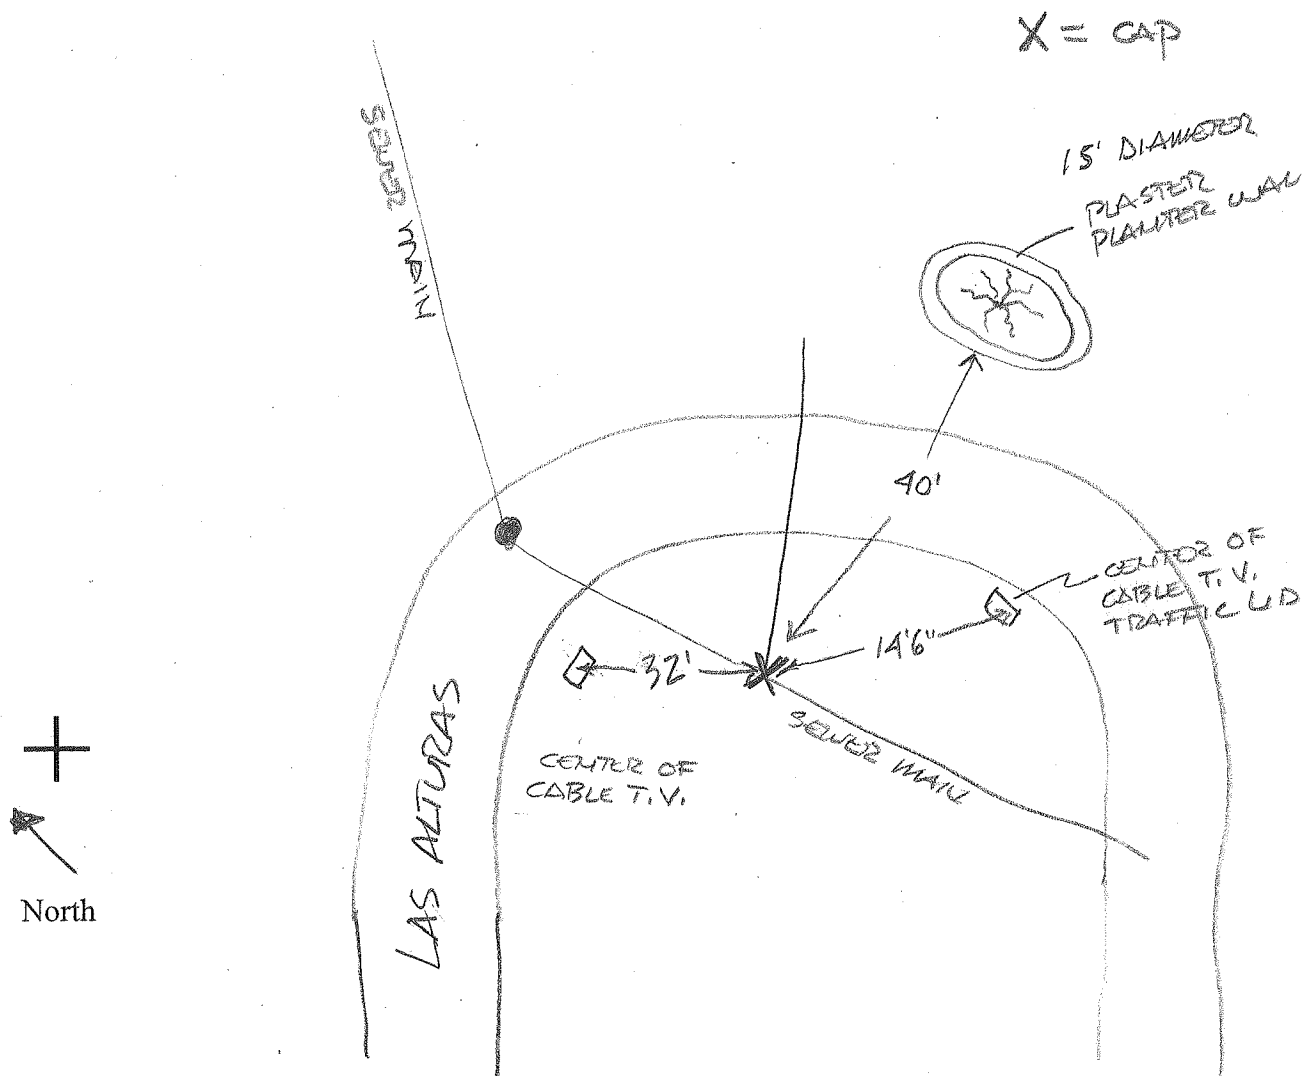
- Date: 1-5-09
- Property Address: 642 LAS ALTURAS
- Location/Address of actual excavation (also see diagram attached):
- Size & material type of sewer main:
- Size & material type of lateral:
- Depth of Wye connection:
- Distance of lateral from centerline of downstream manhole:
- Excavation dimensions:
- Brief description of the site (utility conflict/traffic/soil type/other issues):

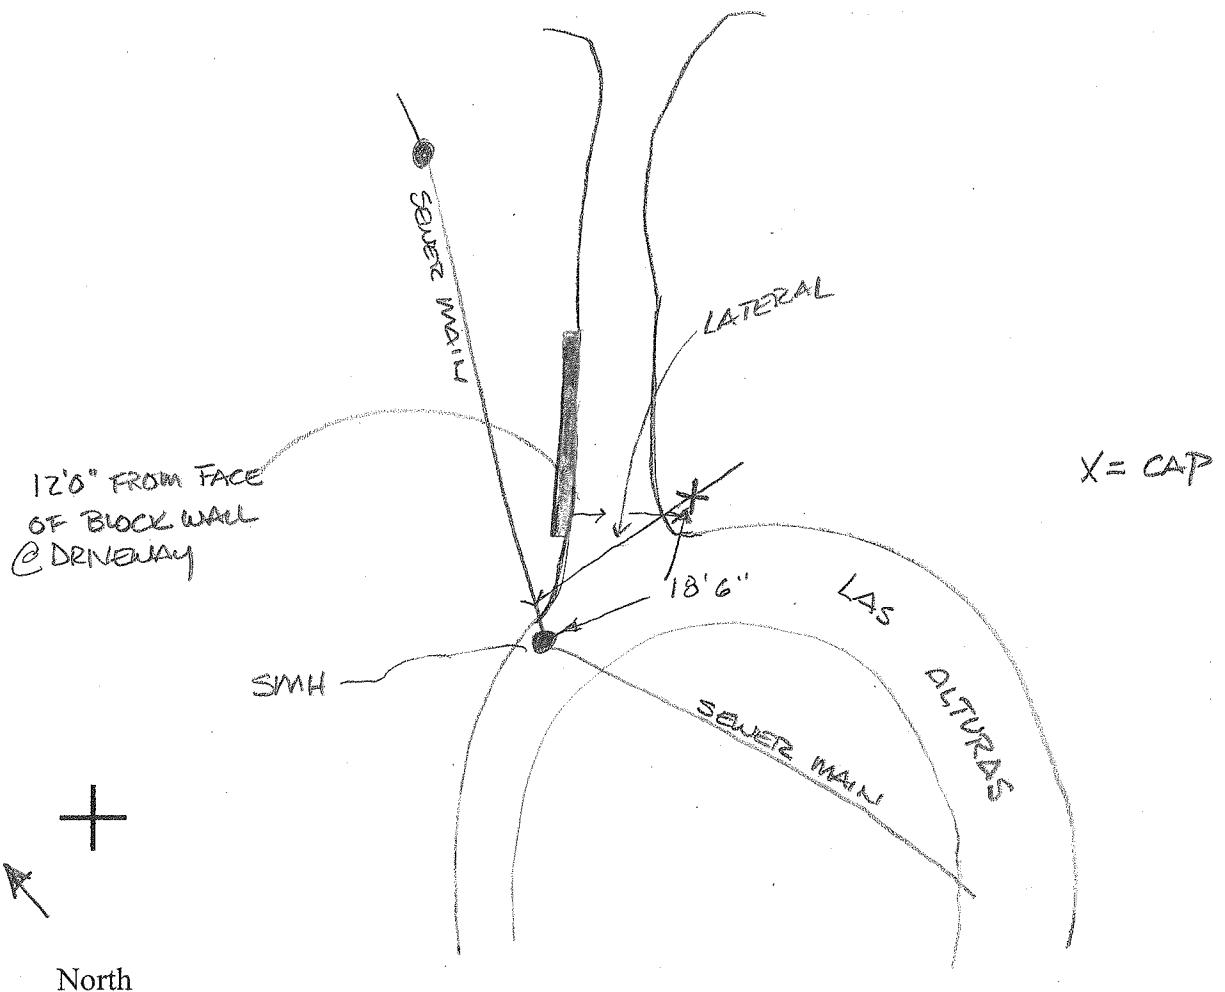
- Date: 1-5-09
- Property Address: 646 LAS ALTURAS
- Location/Address of actual excavation (also see diagram attached):
- Size & material type of sewer main:
- Size & material type of lateral:
- Depth of Wye connection:
- Distance of lateral from centerline of downstream manhole:
- Excavation dimensions:
- Brief description of the site (utility conflict/traffic/soil type/other issues): FORCE LATERAL

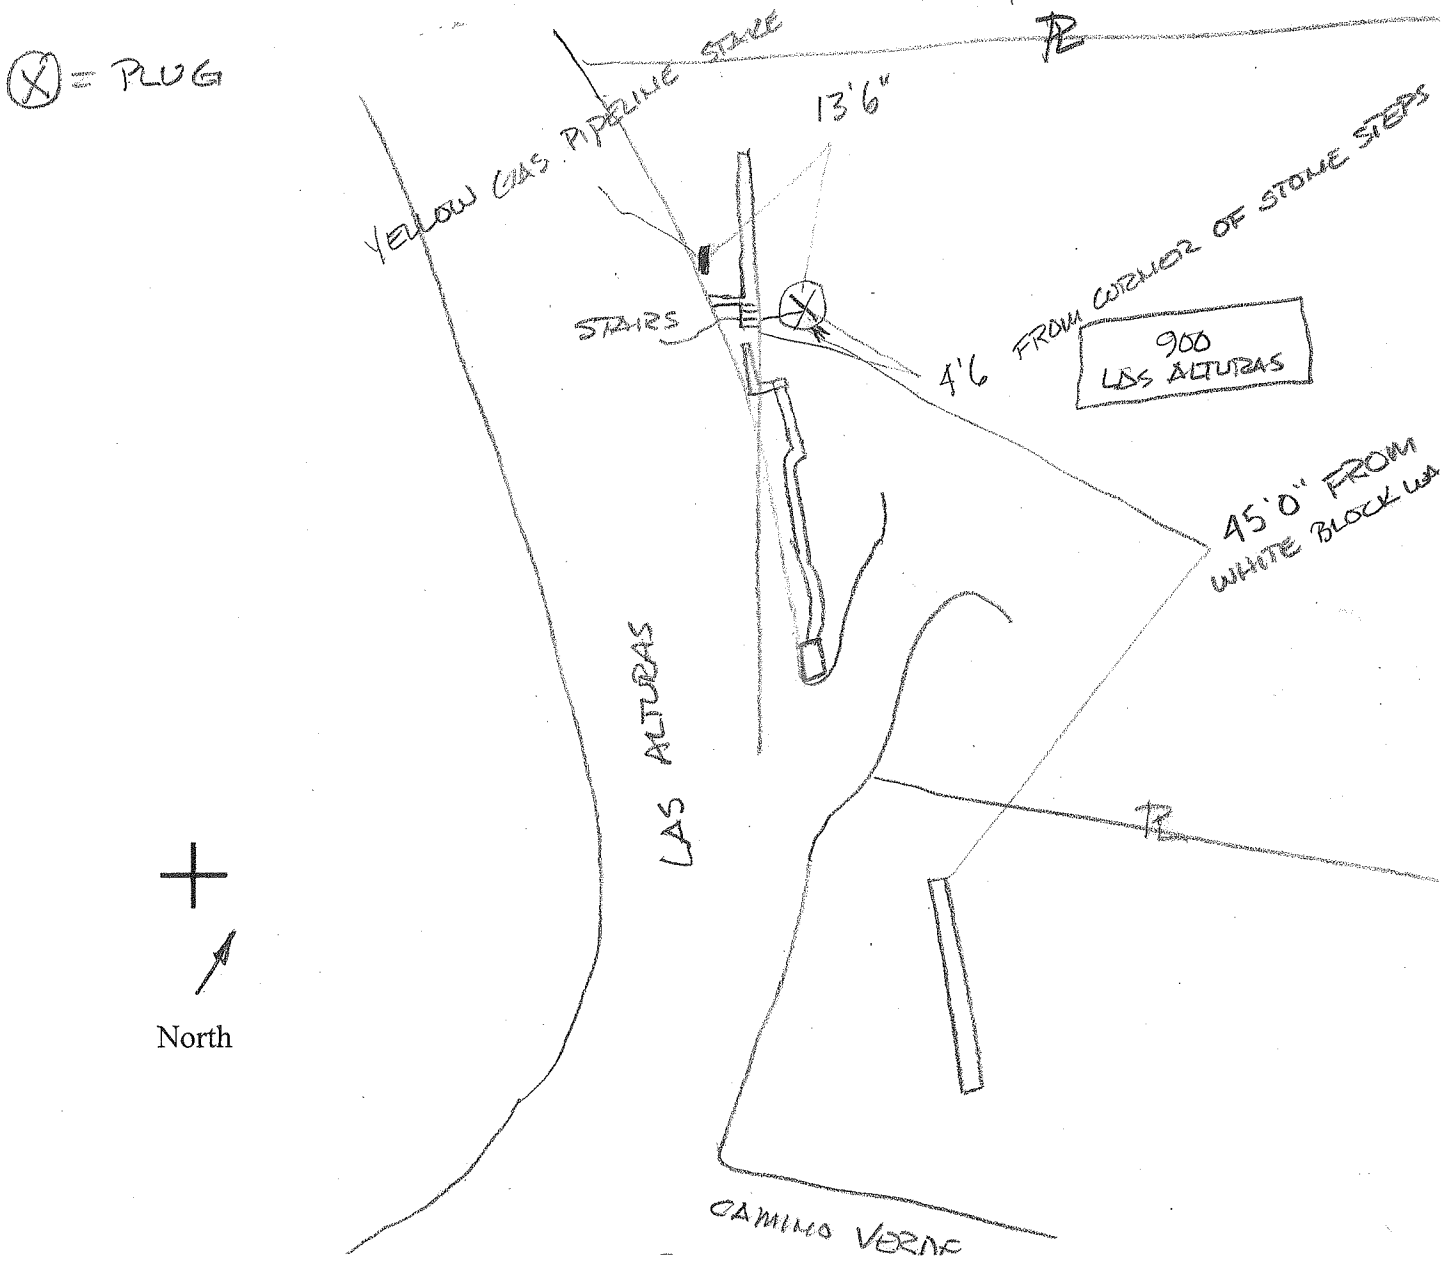
- Date: 1-16-09
- Property Address: 900 LAS ALTURAS
- Location/Address of actual excavation (also see diagram attached):
- Size & material type of sewer main: N/A
- Size & material type of lateral: 4" ABS
- Depth of ^{CAP}Wye connection: 30"
- Distance of lateral from centerline of downstream manhole:
- Excavation dimensions: 2x2
- Brief description of the site (utility conflict/traffic/soil type/other issues):

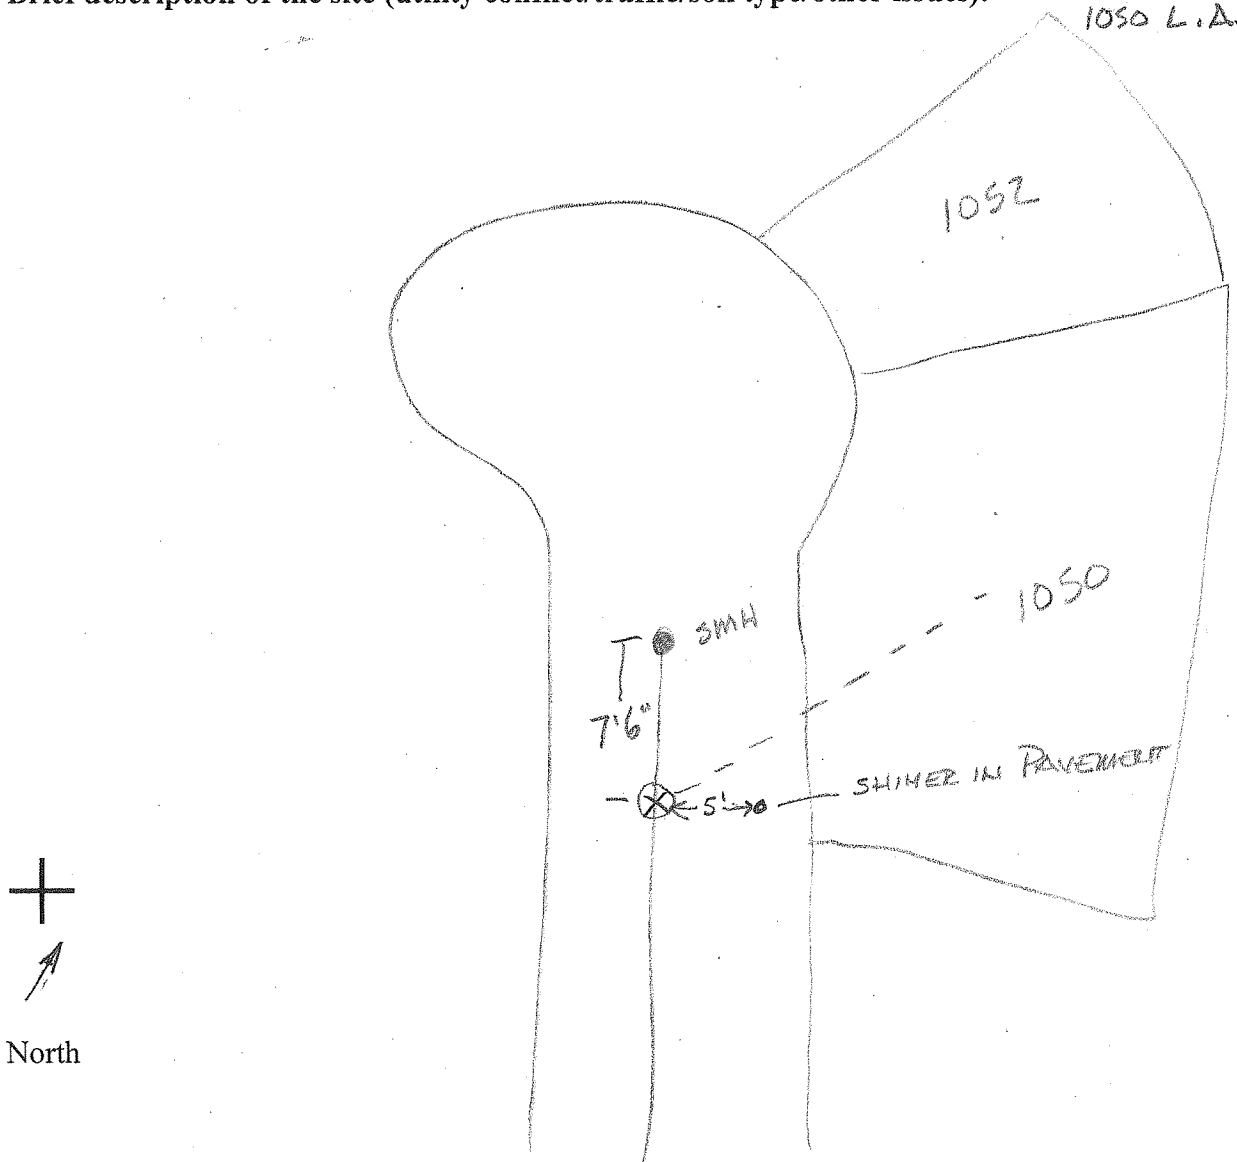
- Date: 1-14-09
- Property Address: 1050 Las Alturas
- Location/Address of actual excavation (also see diagram attached):
- Size & material type of sewer main: CLAY
- Size & material type of lateral: 4" CLAY
- Depth of Wye connection: 5'6"
- Distance of lateral from centerline of downstream manhole: N/A
- Excavation dimensions: 5x2
- Brief description of the site (utility conflict/traffic/soil type/other issues):

CLAY WYE FOR
1052 LAS ALTURA
15'8" SOUTH OF
1050 L.A.

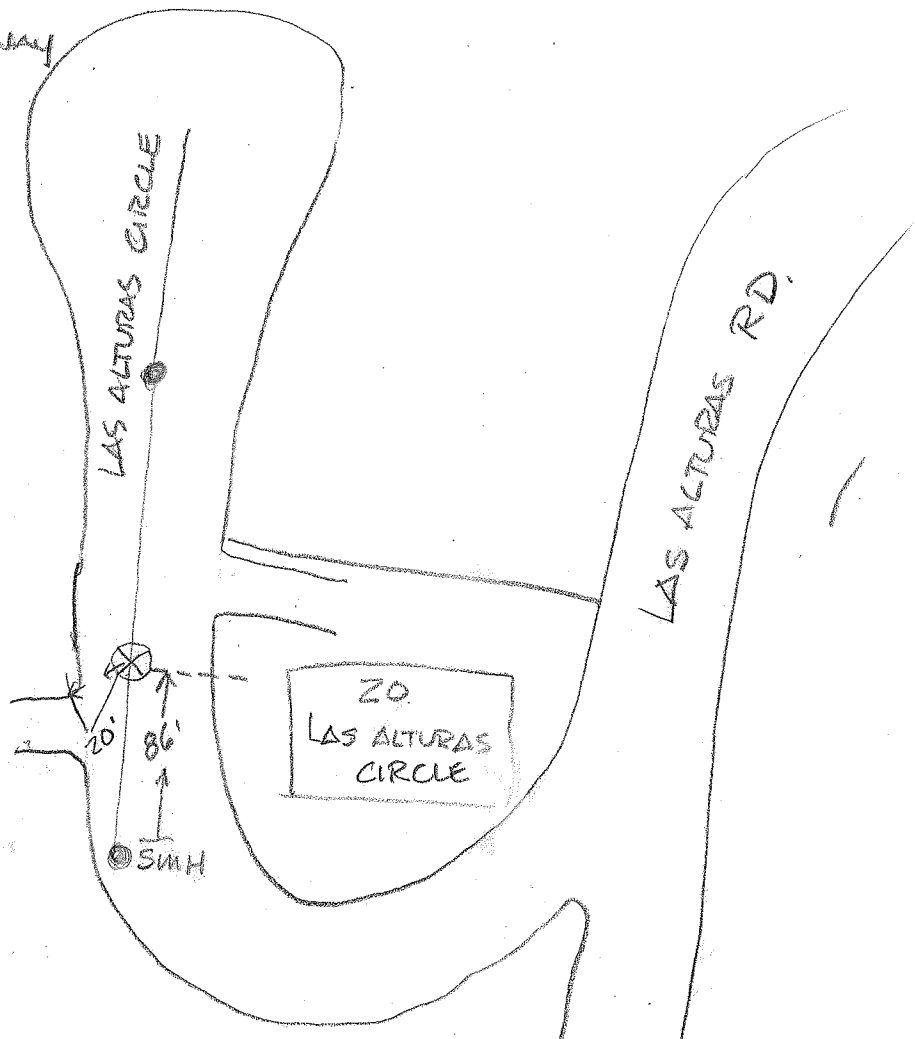
- Date: 1-14-09
- Property Address: 20 LAS ALTURAS CIRCLE
- Location/Address of actual excavation (also see diagram attached):
- Size & material type of sewer main:
- Size & material type of lateral: 1" CLAY
- Depth of Wye connection: 4'6"
- Distance of lateral from centerline of downstream manhole: 86'
- Excavation dimensions: 2x4
- Brief description of the site (utility conflict/traffic/soil type/other issues):

⊗ = PLUG

20' SOUTHEAST FROM 23
LAS ALTURAS
(CORNER OF PAYER DENEWAY)

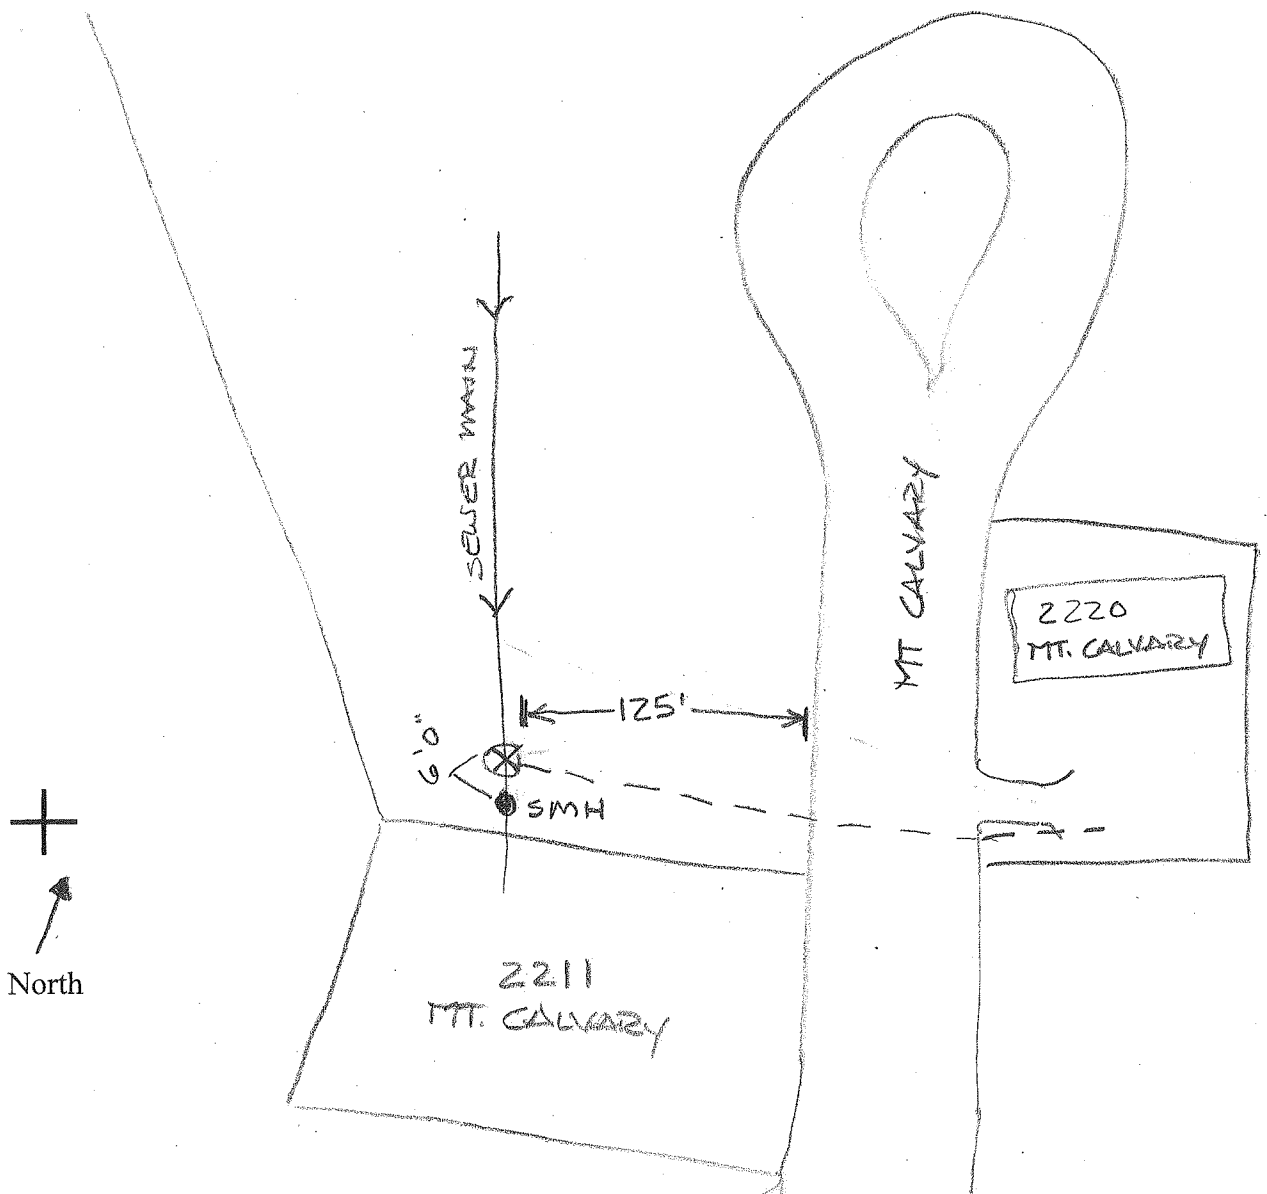
- Date: 1-16-09
- Property Address: 2220
- Location/Address of actual excavation (also see diagram attached):
- Size & material type of sewer main:
- Size & material type of lateral: CAST IRON TO PVC (FORCE LATERAL)
- Depth of ^{PLUG}Wye connection: 18"
- Distance of lateral from centerline of downstream manhole:
- Excavation dimensions: 2x2
- Brief description of the site (utility conflict/traffic/soil type/other issues): FORCE LATERAL

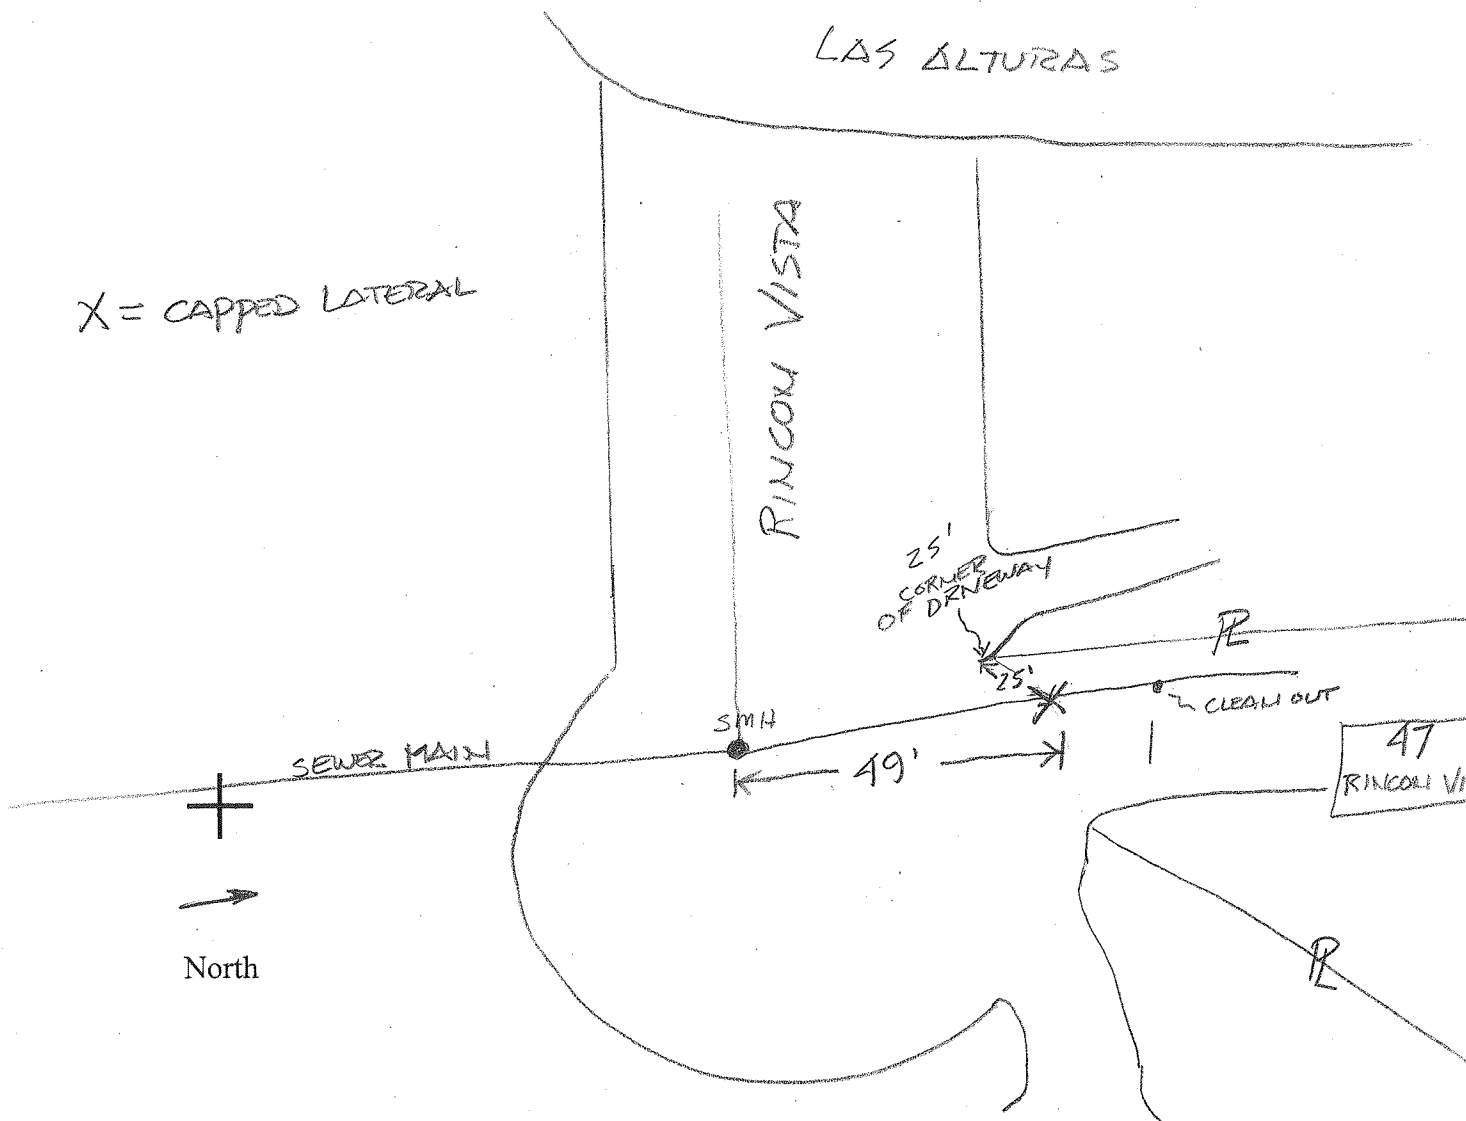
- Date: 1-7-09
- Property Address: 47 RINCOL VISTA
- Location/Address of actual excavation (also see diagram attached): SAME
- Size & material type of sewer main: N/A
- Size & material type of lateral: 4" ABS
- Depth of ^{CAP}Wye connection: 27"
- Distance of lateral from centerline of downstream manhole:
- Excavation dimensions:
- Brief description of the site (utility conflict/traffic/soil type/other issues):

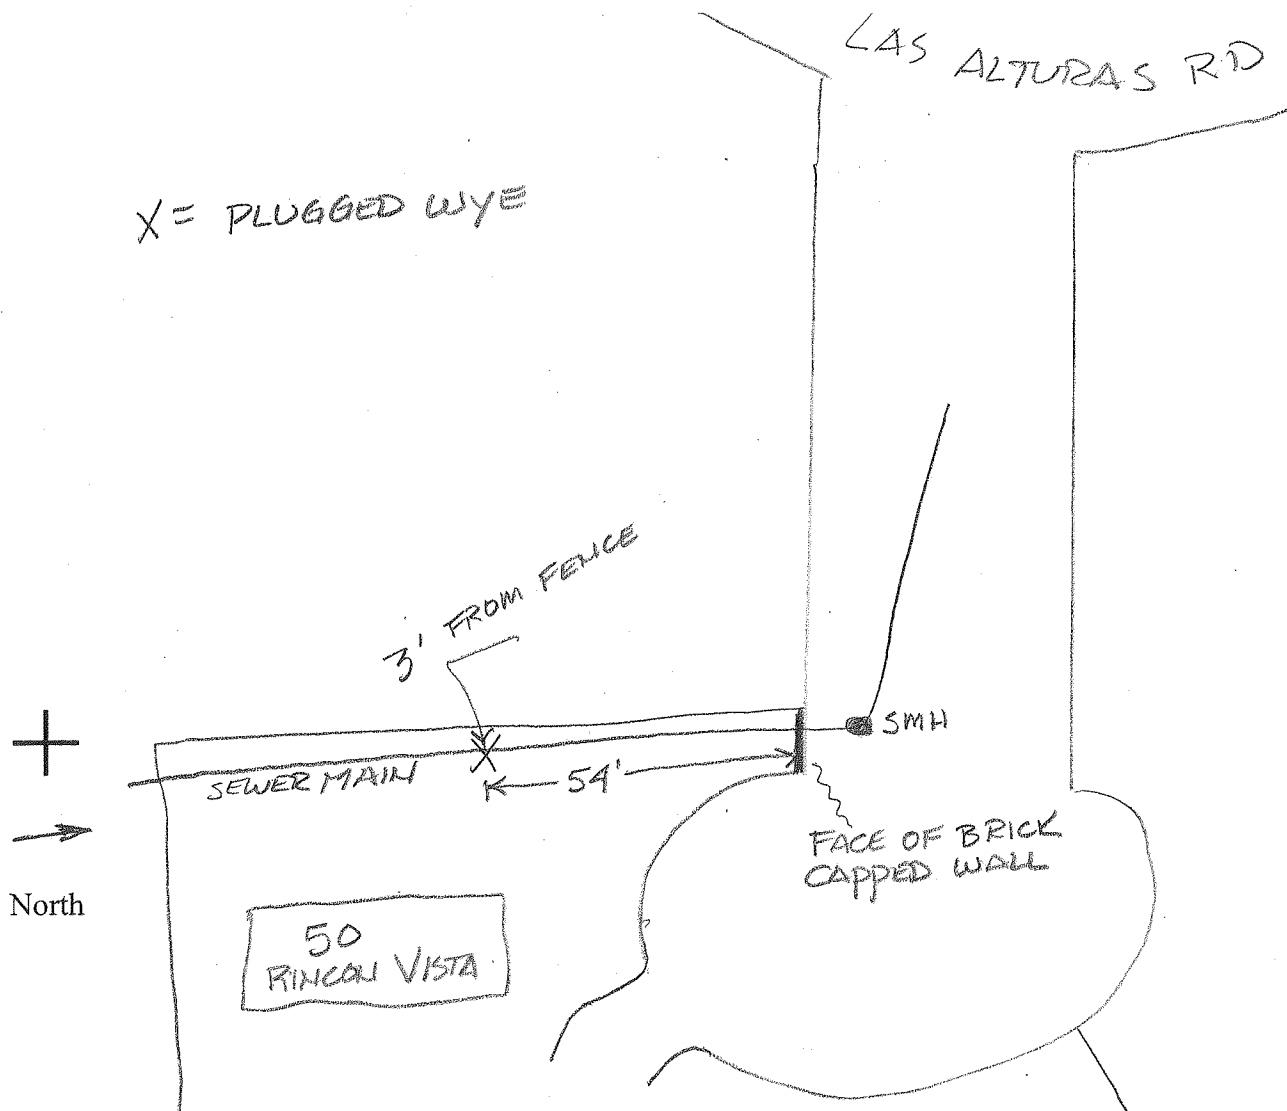
- Date: 1-7-09
- Property Address: 50 RINCON VISTA
- Location/Address of actual excavation (also see diagram attached):
- Size & material type of sewer main: CLAY
- Size & material type of lateral: 4" ABS
- Depth of ^{CAP}Wye connection: 30"
- Distance of lateral from centerline of downstream manhole:
- Excavation dimensions: 3 X 3
- Brief description of the site (utility conflict/traffic/soil type/other issues): NONE

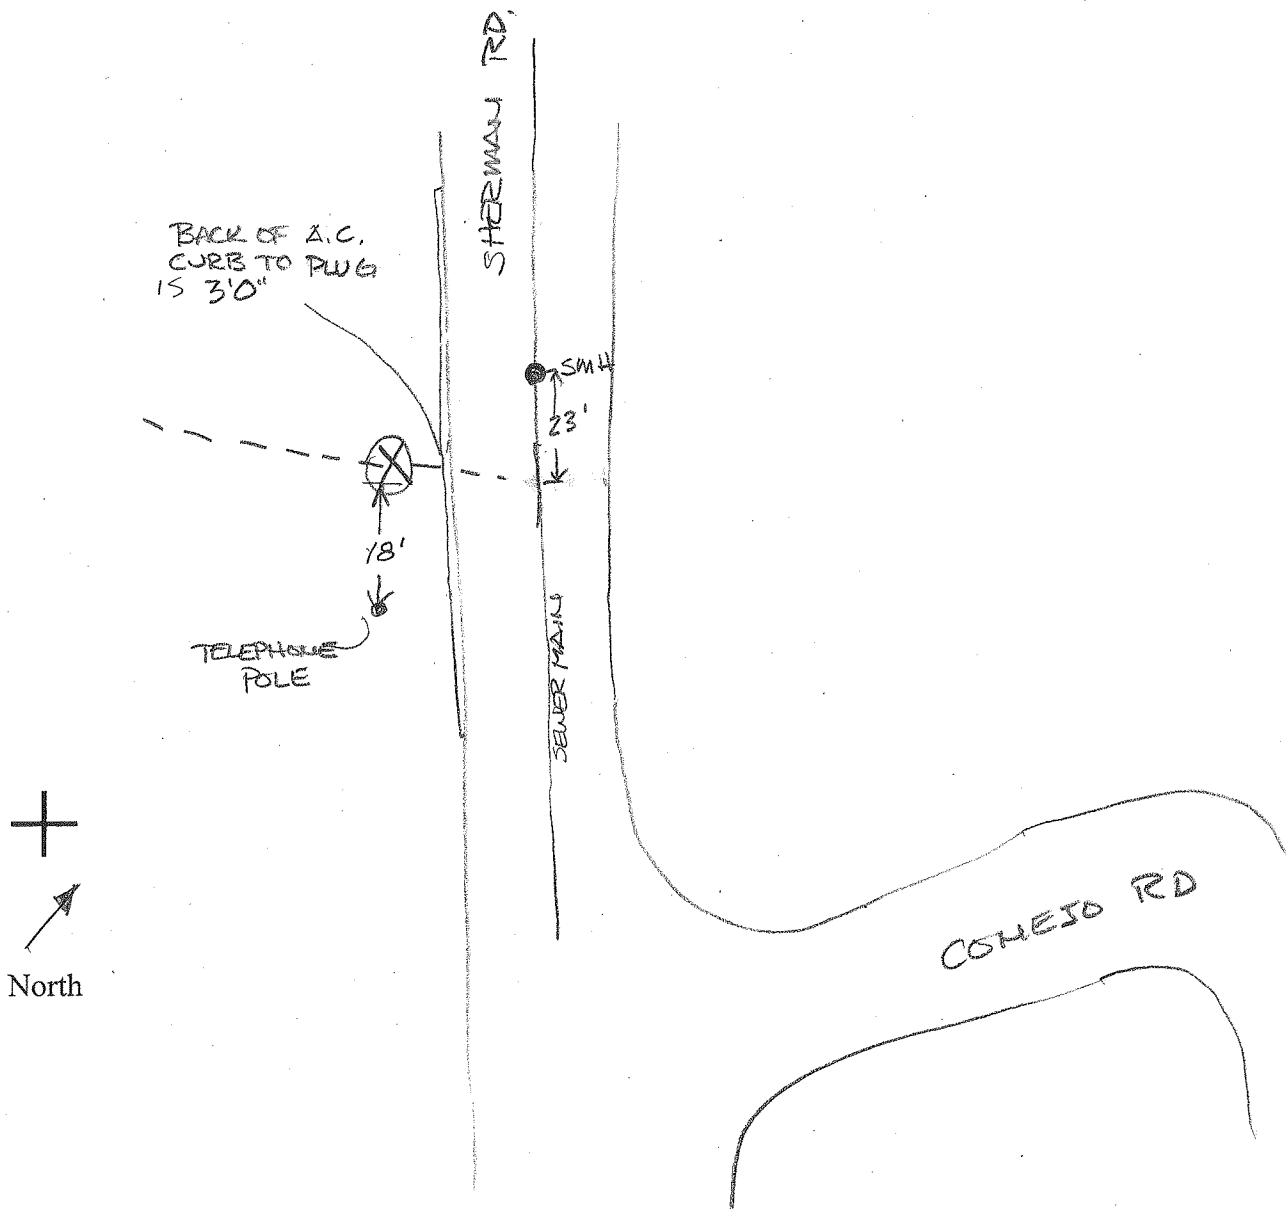
- Date: 1-13-09
- Property Address: 317 SHERMAN RD,
- Location/Address of actual excavation (also see diagram attached):
- Size & material type of sewer main: N/A
- Size & material type of lateral: 4" CLAY
- Depth of ^{PLUG}Wye connection: 6'
- Distance of lateral from centerline of downstream manhole:
- Excavation dimensions: 5 X 3
- Brief description of the site (utility conflict/traffic/soil type/other issues): NONE

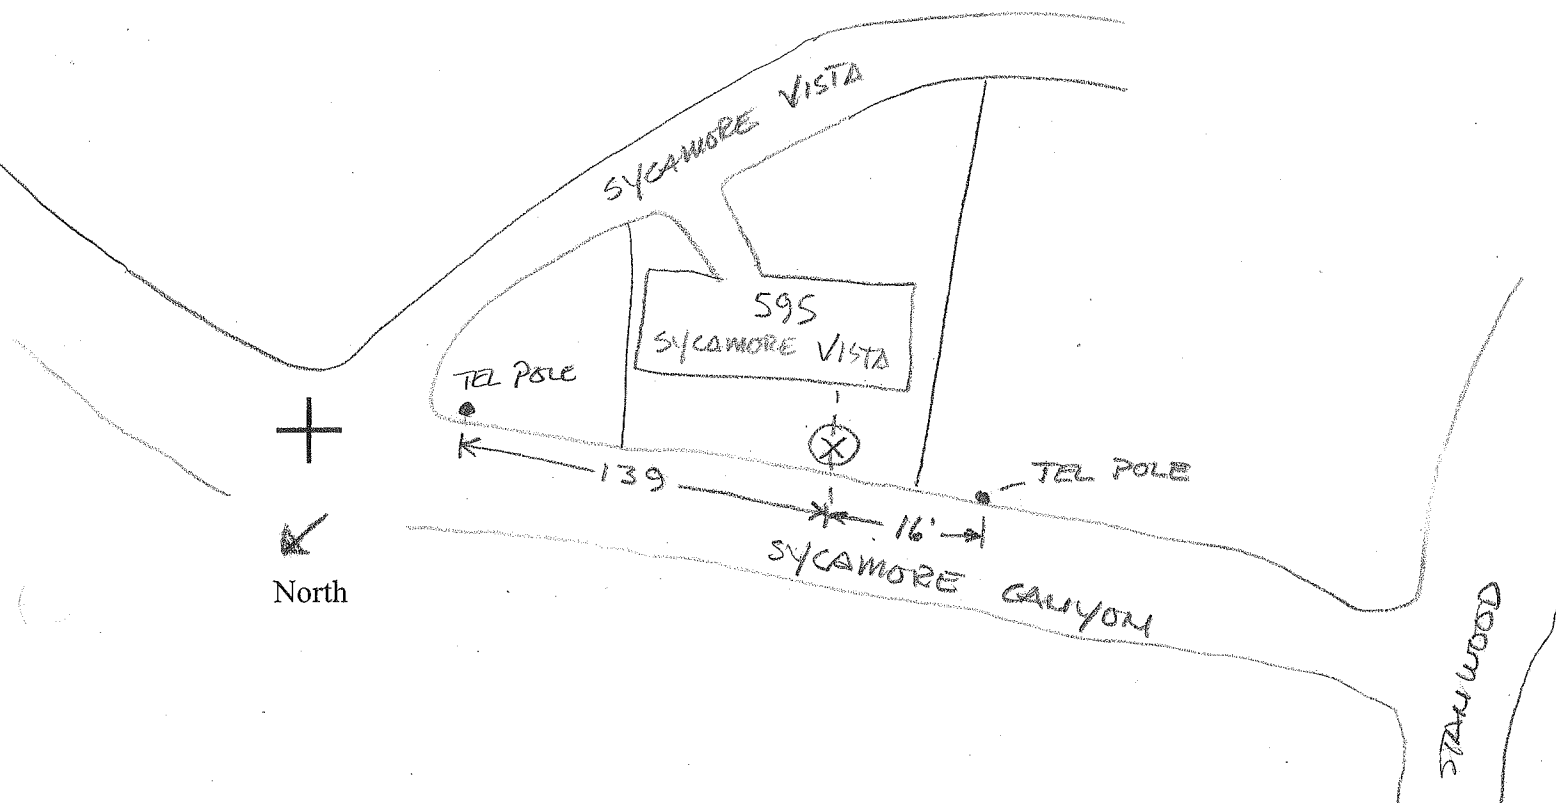
- Date: 1-16-09
- Property Address: 595 SYCAMORE VISTA
- Location/Address of actual excavation (also see diagram attached):
- Size & material type of sewer main: N/A
- Size & material type of lateral: 3" SDR
- Depth of ^{cap}Wye connection: @ GRADE
- Distance of lateral from centerline of downstream manhole: N/A
- Excavation dimensions: N/A
- Brief description of the site (utility conflict/traffic/soil type/other issues): EXPOSED LINE & PLUGS

⊗ = PLUG

20' 0" FROM EDGE OF PAVEMENT

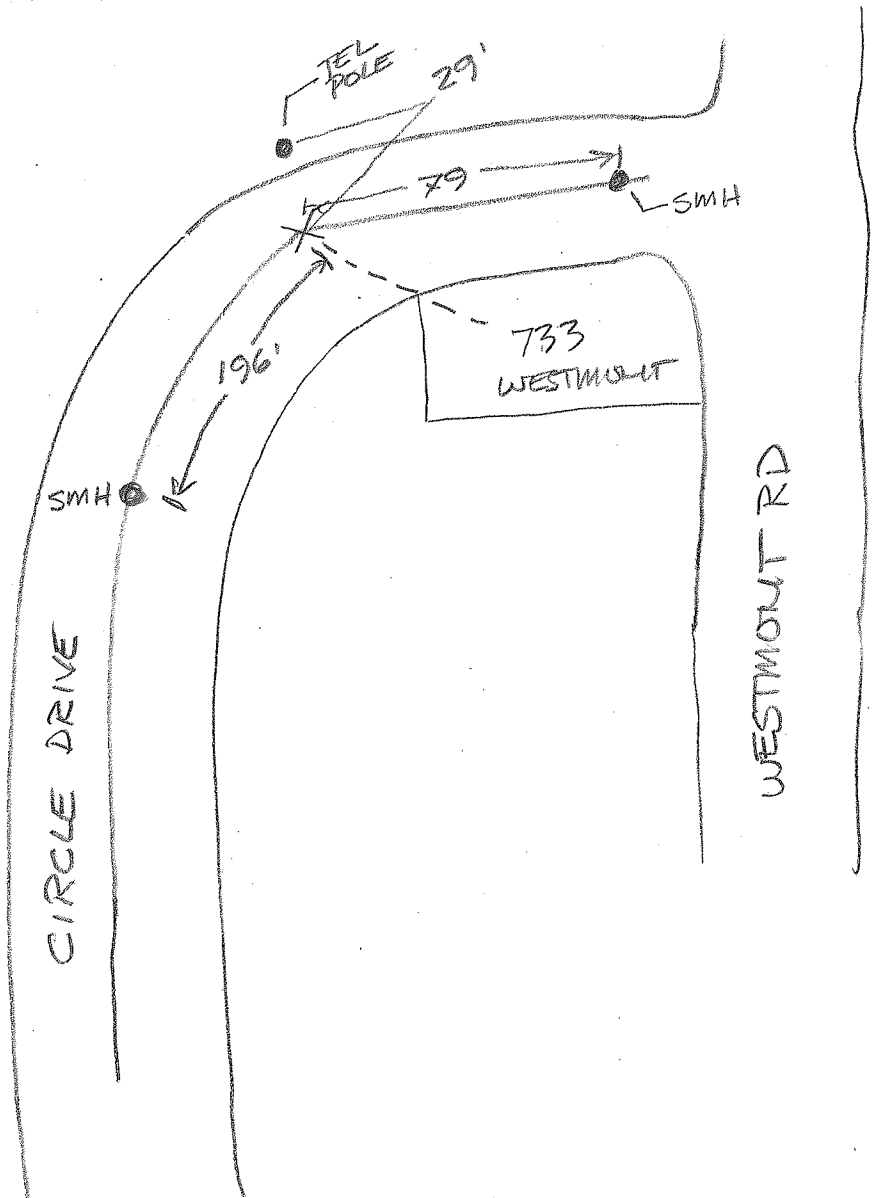
- Date: 1-5-09
- Property Address: 733 WESTMONT
- Location/Address of actual excavation (also see diagram attached): ON CIRCLE
- Size & material type of sewer main:
- Size & material type of lateral:
- Depth of Wye connection: 7'
- Distance of lateral from centerline of downstream manhole: 196'
- Excavation dimensions: 2x3
- Brief description of the site (utility conflict/traffic/soil type/other issues): KLOVE

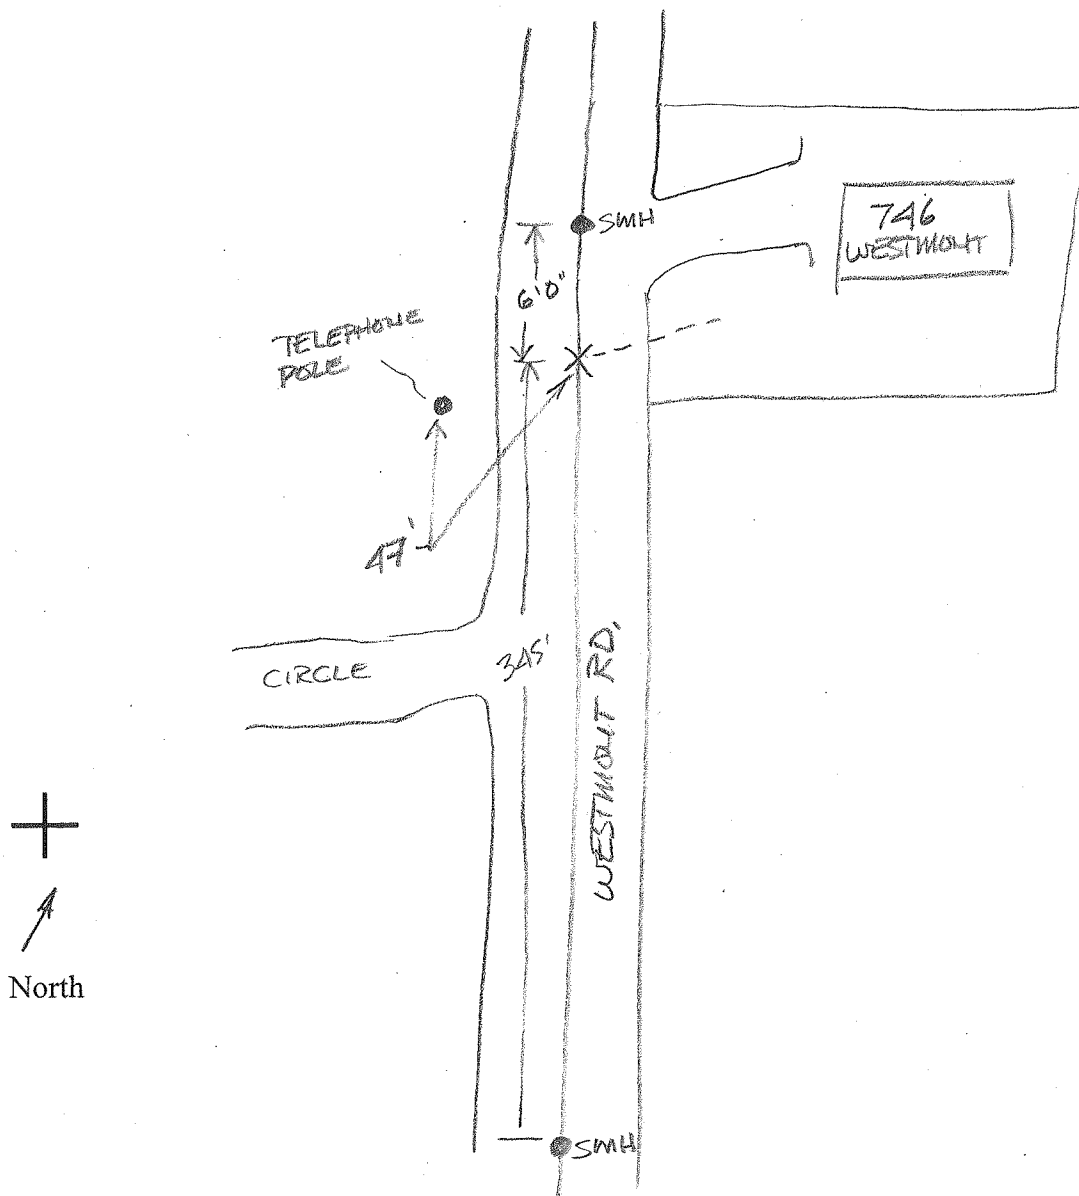
- Date: 1-5-09
- Property Address: 746 WESTMOUNT
- Location/Address of actual excavation (also see diagram attached):
- Size & material type of sewer main:
- Size & material type of lateral:
- Depth of Wye connection: 4'
- Distance of lateral from centerline of downstream manhole: 345'
- Excavation dimensions: 2x4
- Brief description of the site (utility conflict/traffic/soil type/other issues): NONE
